KEY MAP
Sediment Probing Interpretation
Bound Brook OU4 RI/FS

Panel A: Surface Sediment Texture and Panel B: Depth of Refusal

Bound Brook OU4 RI/FS

L B Cornell-Dubilier Electronics
Superfund Site
South Plainfield, New Jersey

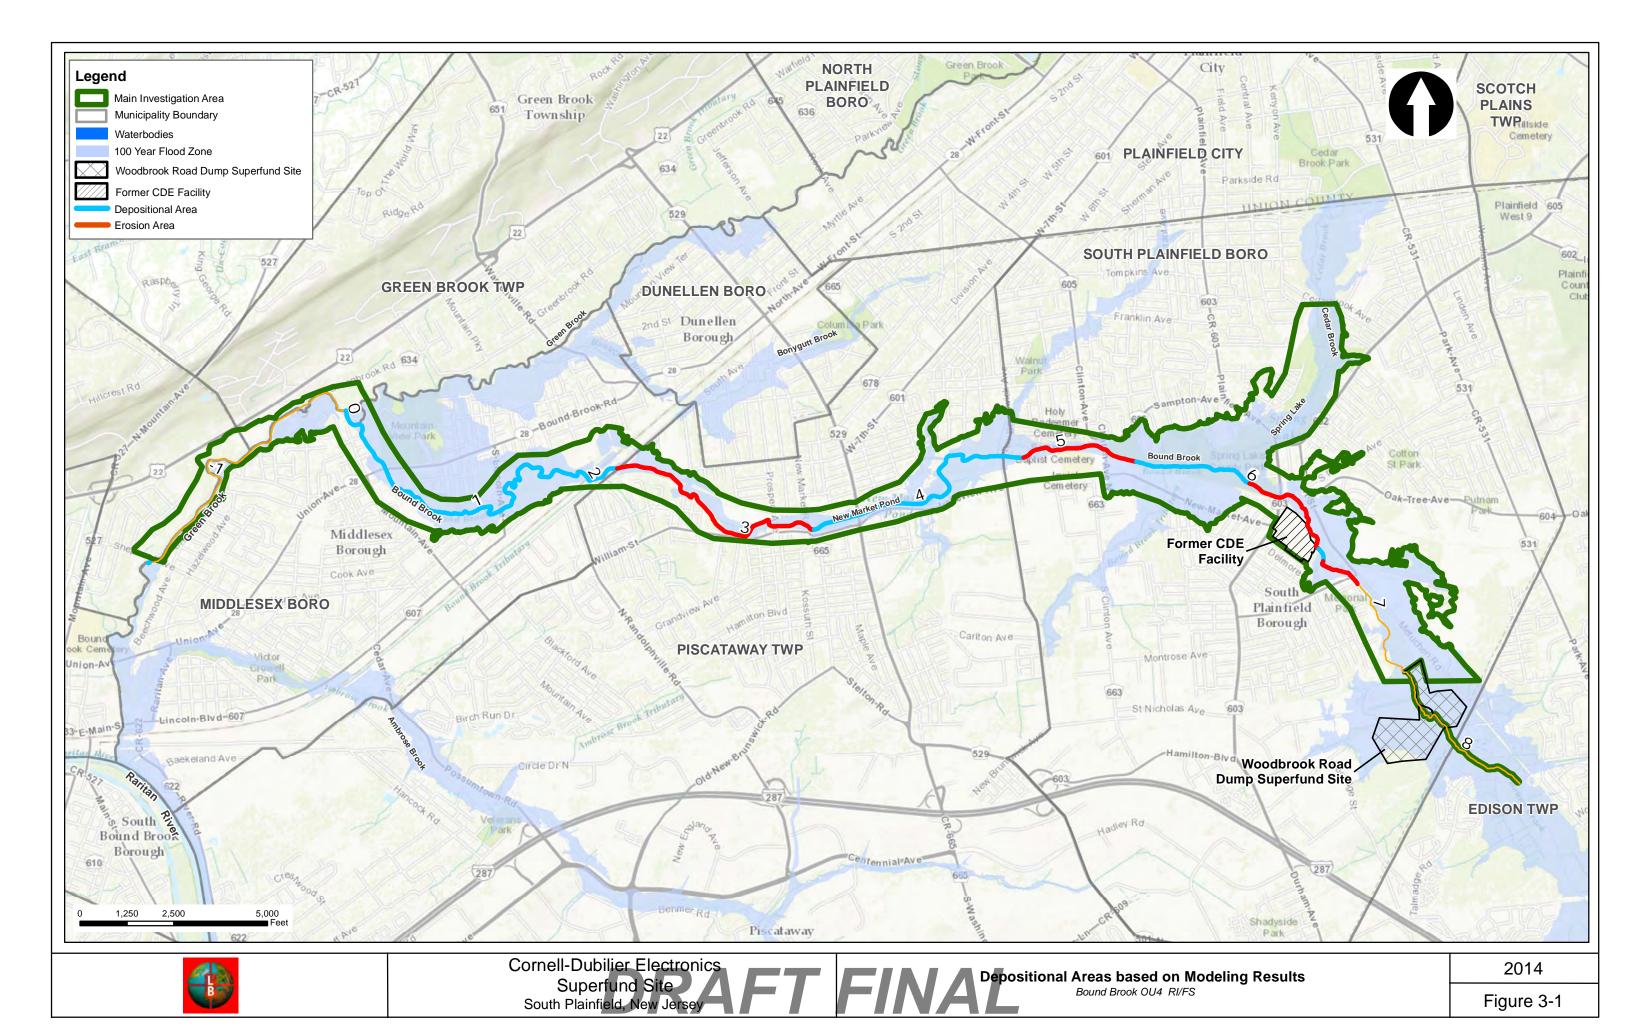
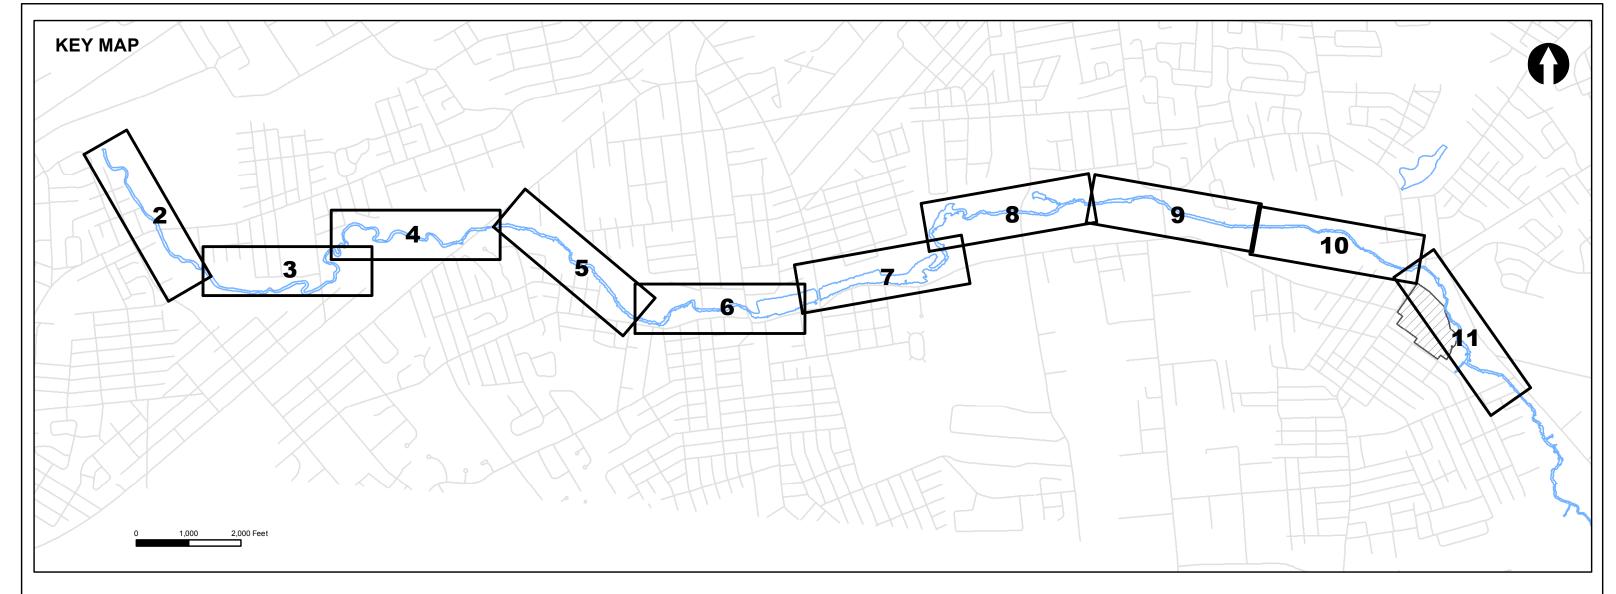
Sand as interpreted by the side scan sonar

Rock-Gravel-Sand as interpreted by the side scan sonar Silt as interpreted by the side scan sonar

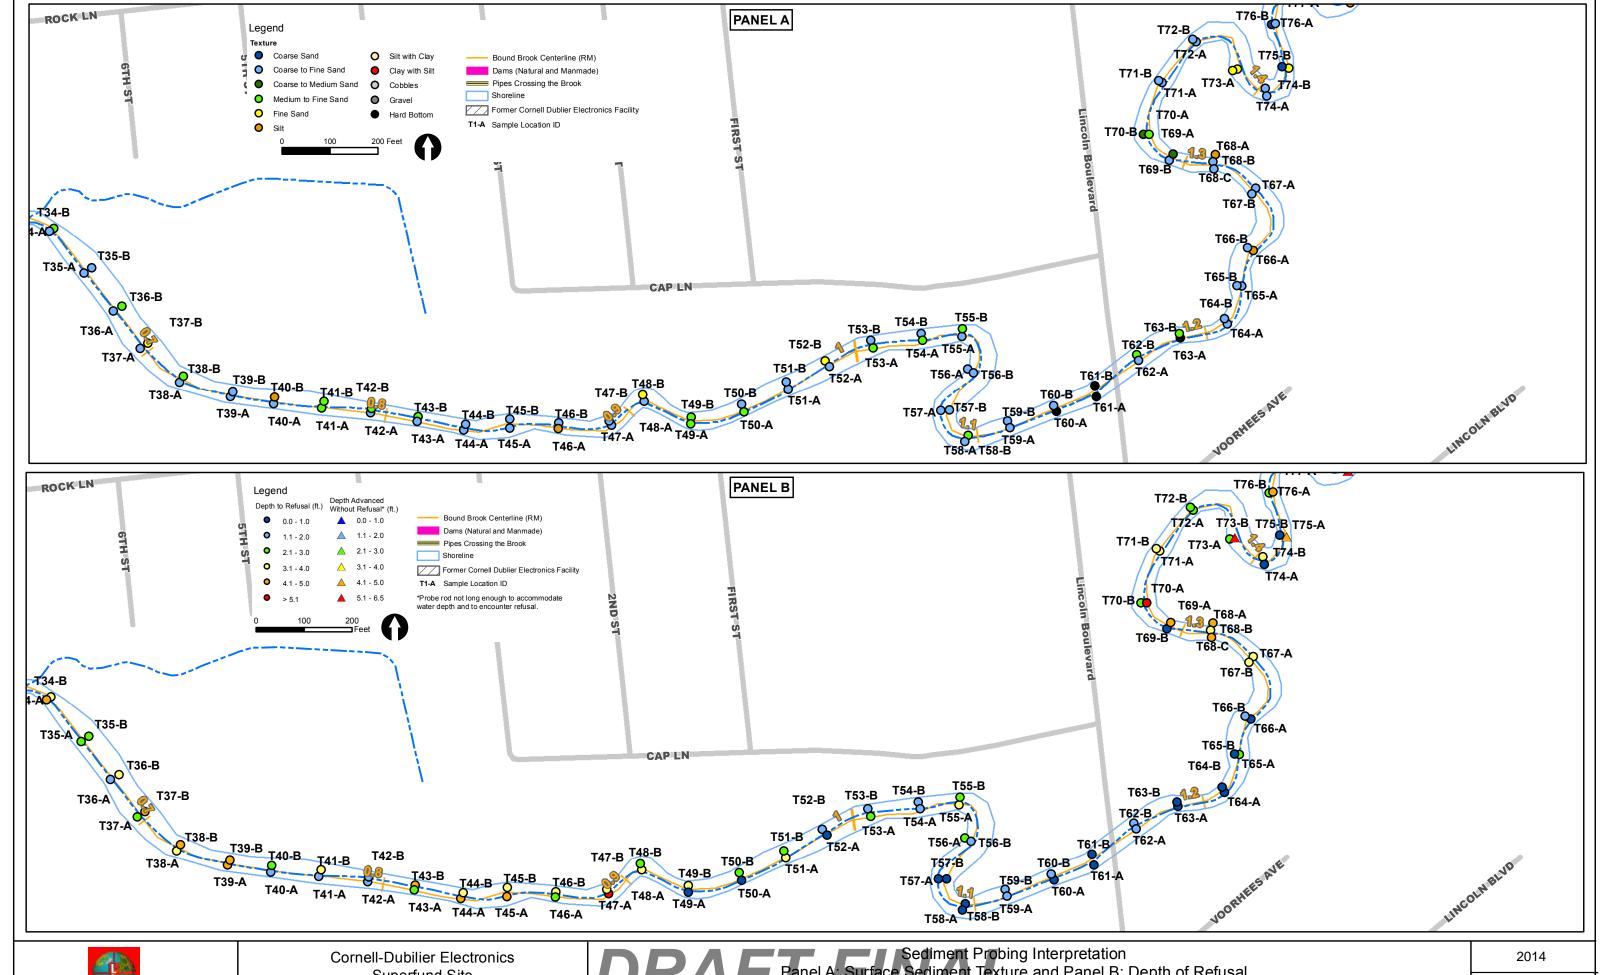
Figure 3-2 Sheet 3 of 11

Sediment Probing Interpretation

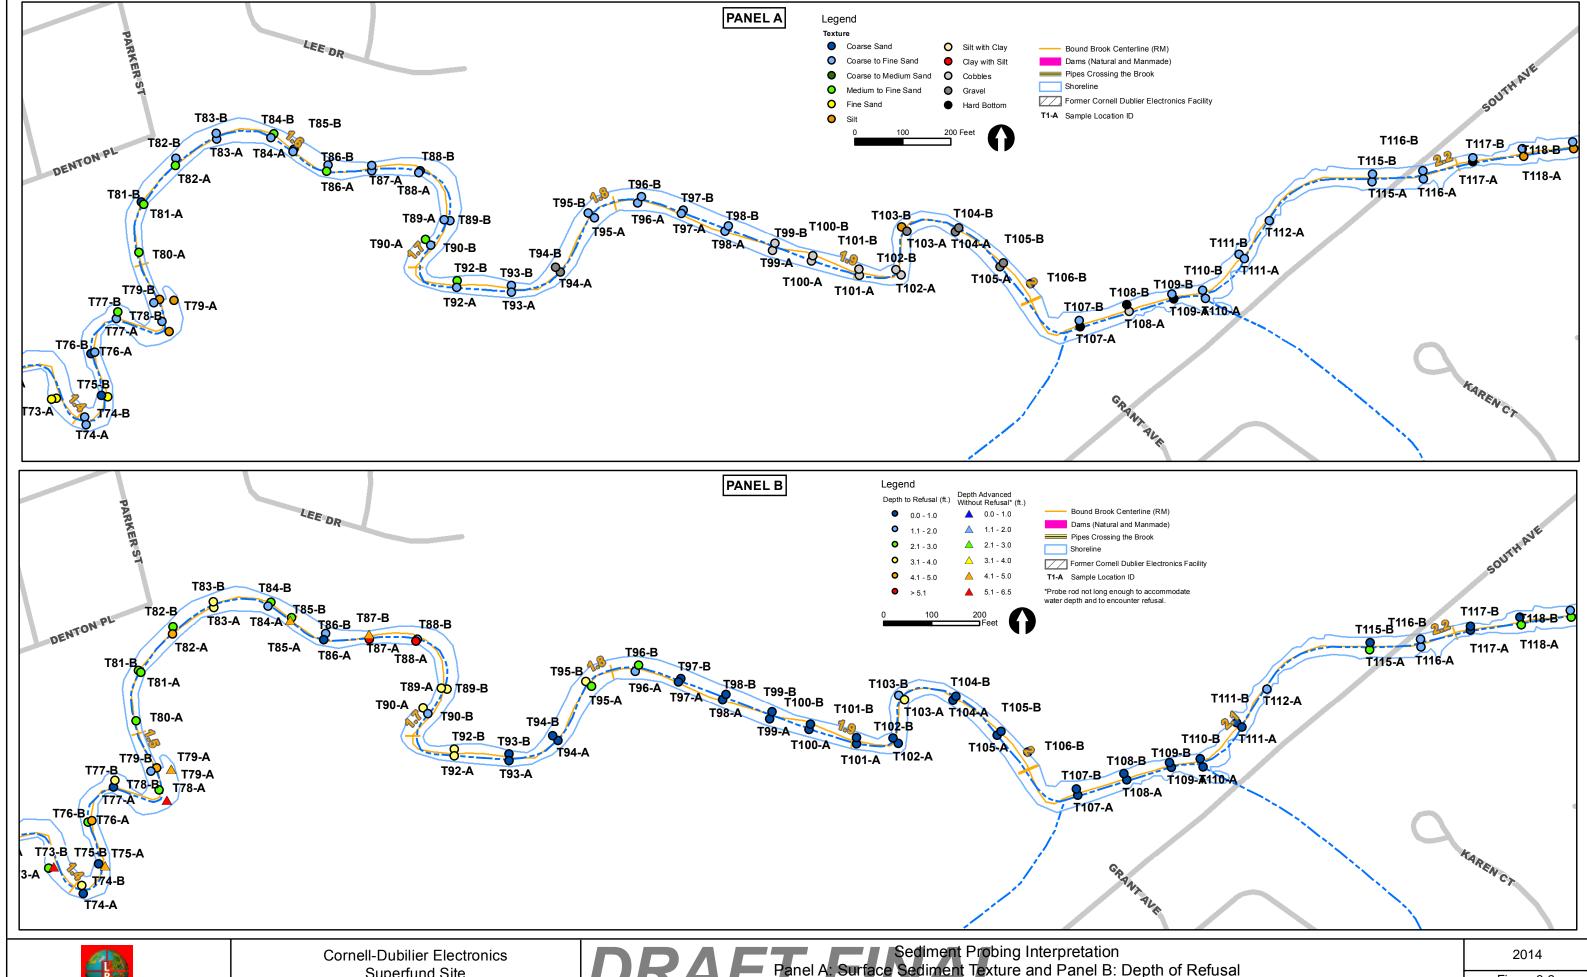
Figure 3-2 Sheet 4 of 11

Sediment Probing Interpretation
Panel A: Surface Sediment Texture and Panel B: Depth of Refusal
Bound Brook OU4 RI/FS

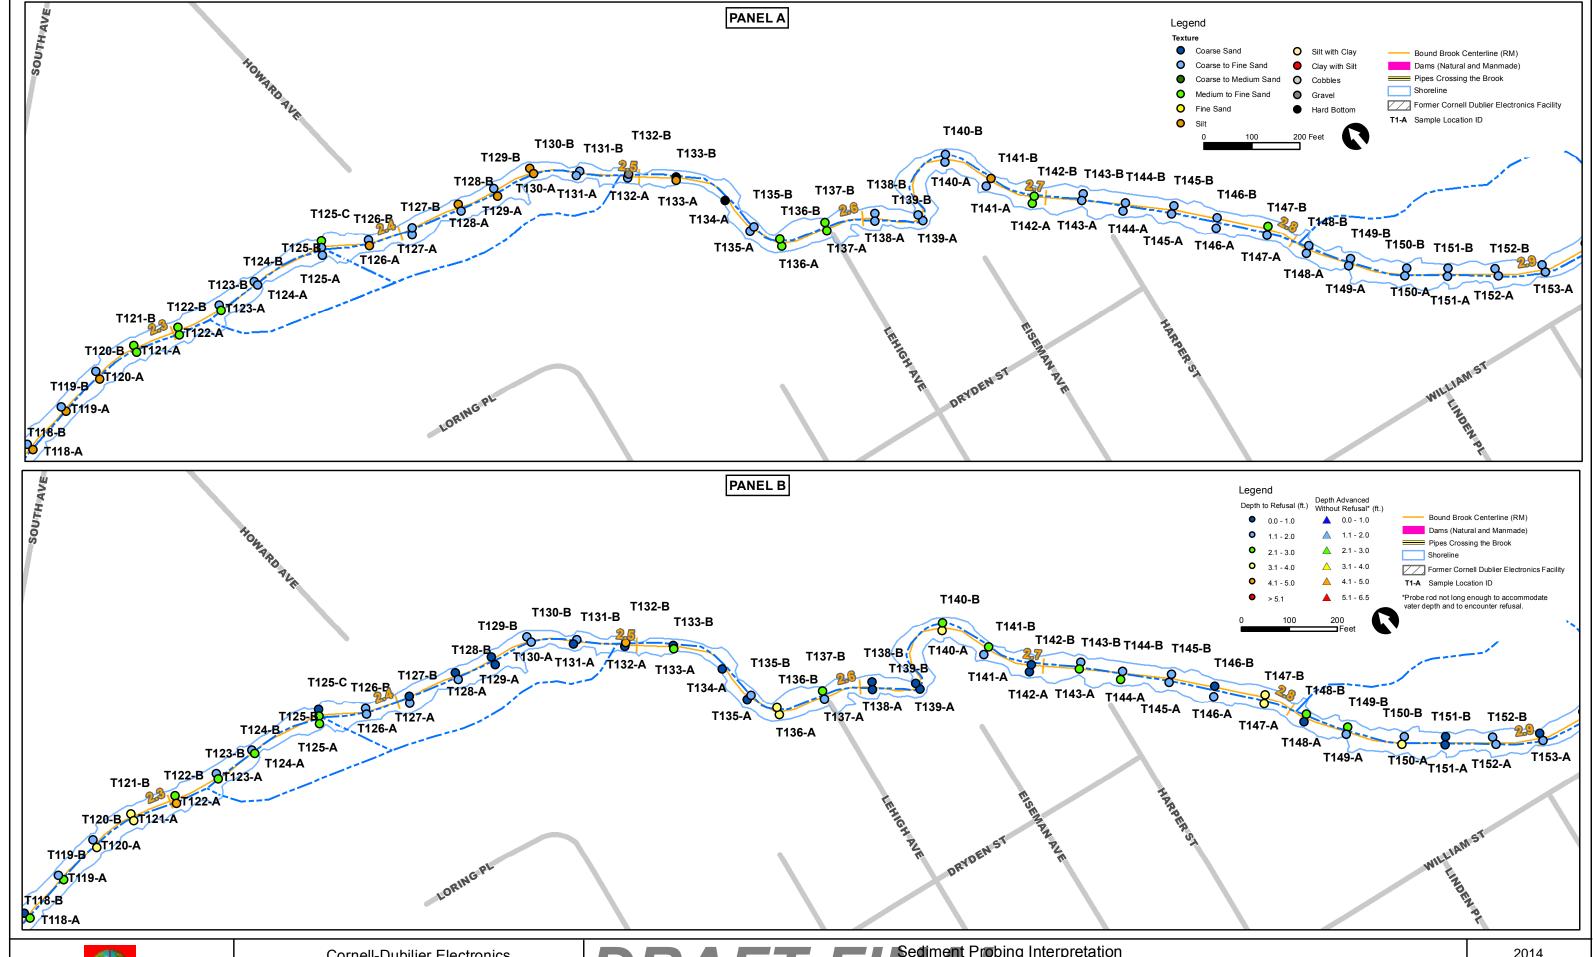
Figure 3-2 Sheet 5 of 11

Sediment Probing Interpretation
Panel A: Surface Sediment Texture and Panel B: Depth of Refusal
Bound Brook OU4 RI/FS

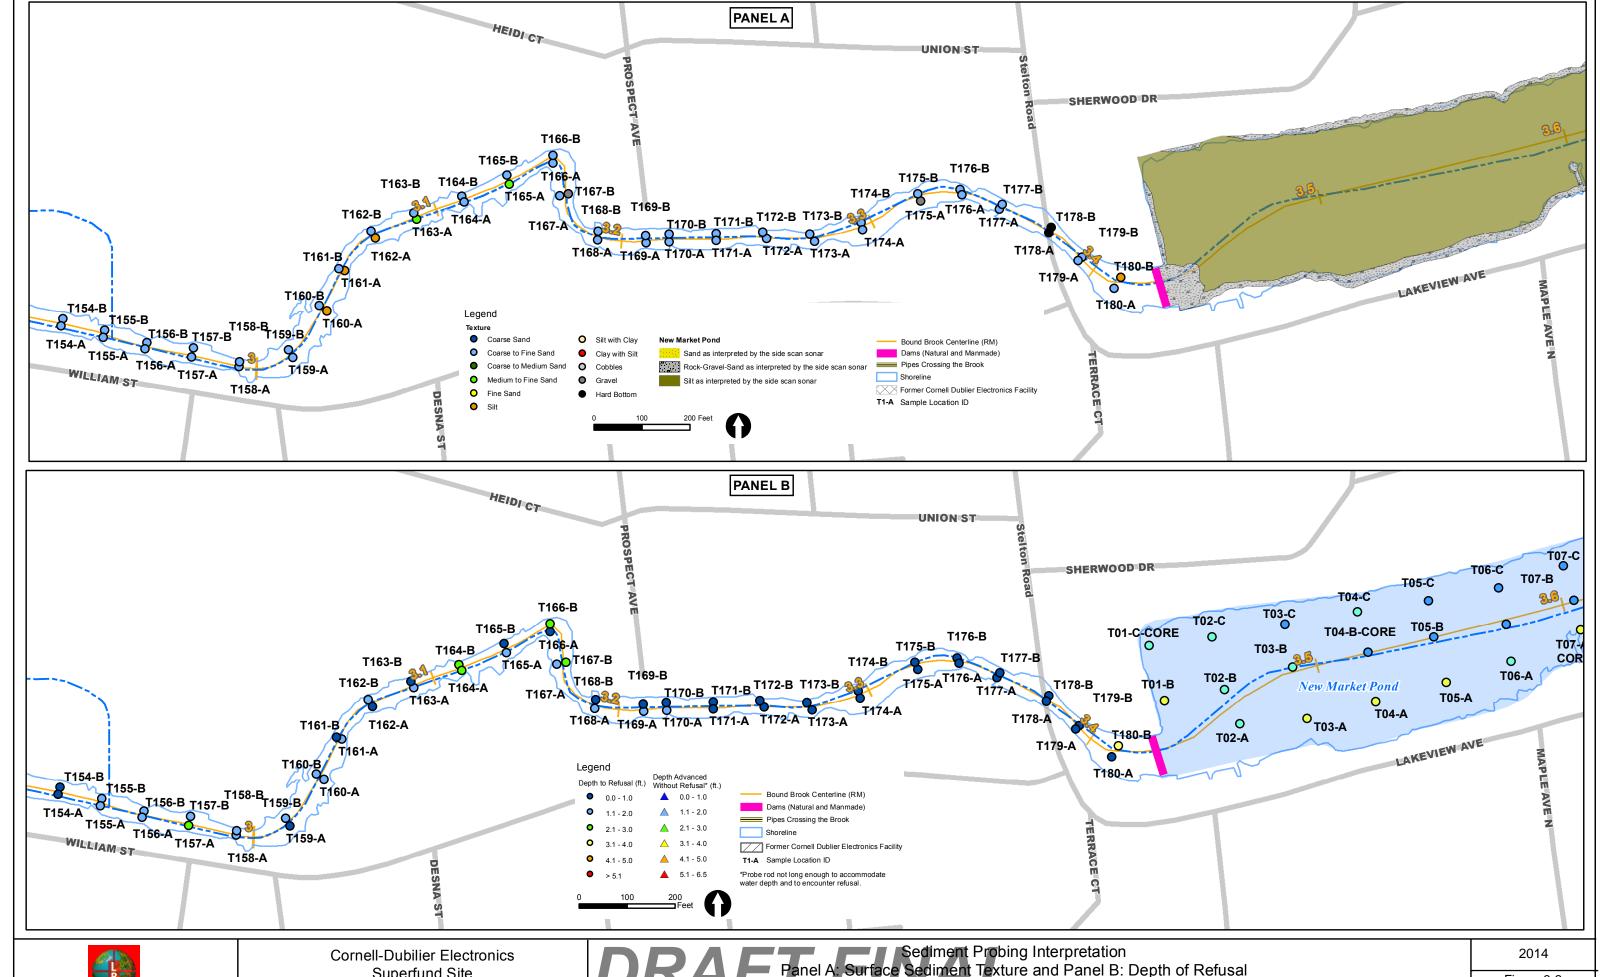
Figure 3-2 Sheet 6 of 11

Sediment Probing Interpretation
Panel A: Surface Sediment Texture and Panel B: Depth of Refusal
Bound Brook OU4 RI/FS

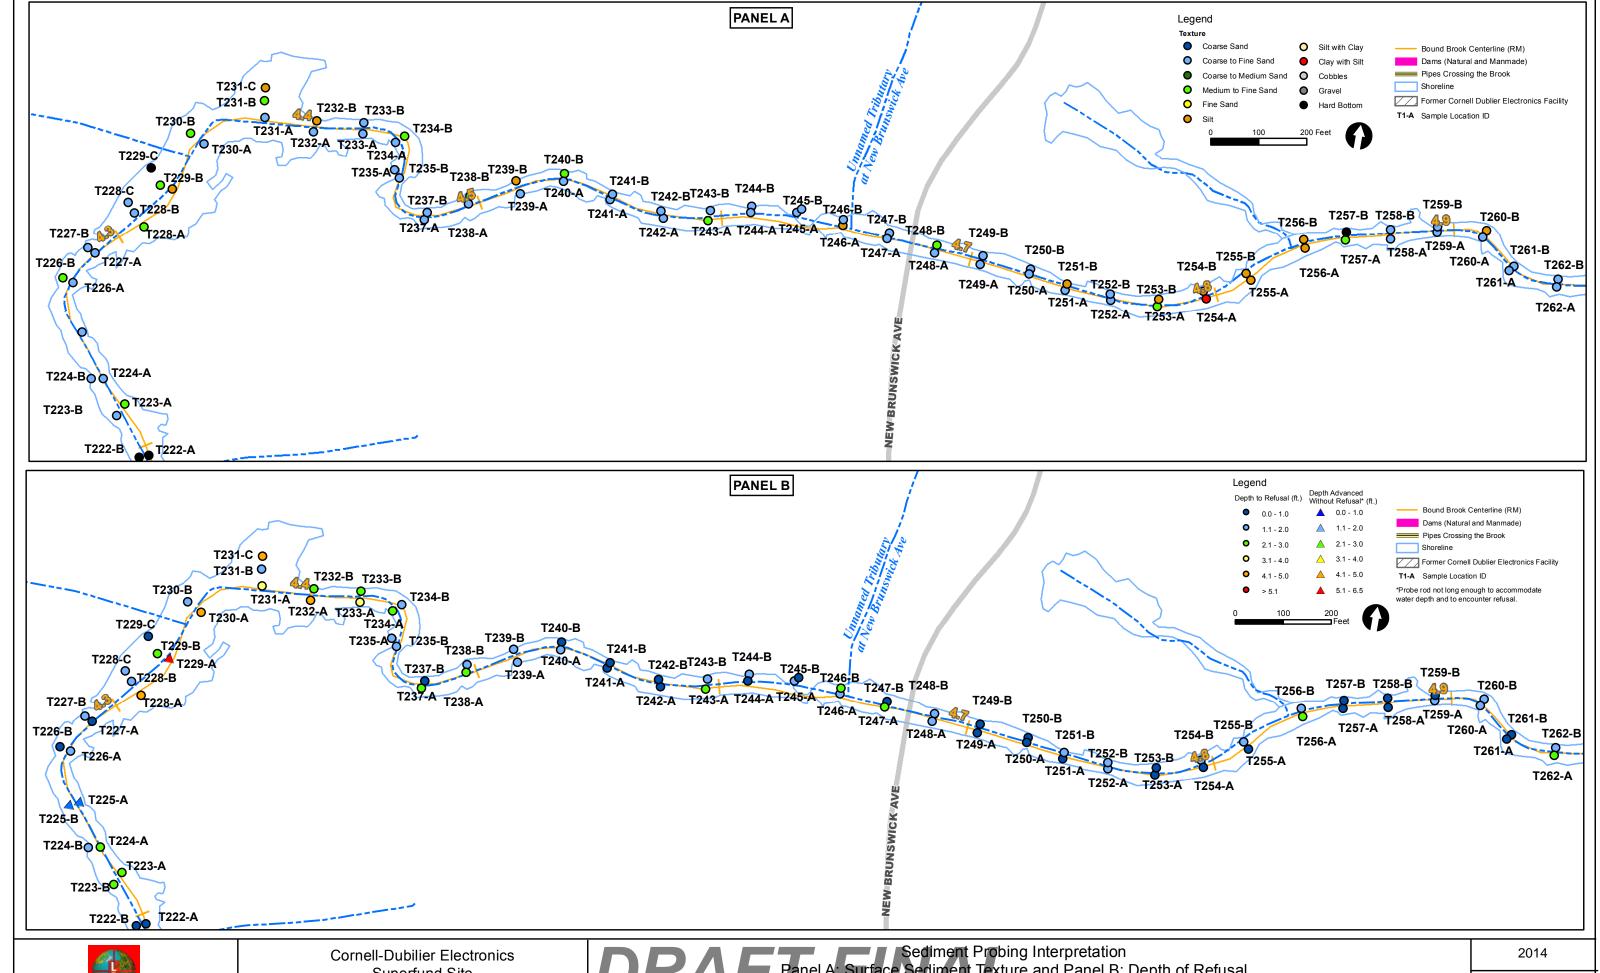
Figure 3-2 Sheet 8 of 11

Sediment Probing Interpretation
Panel A: Surface Sediment Texture and Panel B: Depth of Refusal

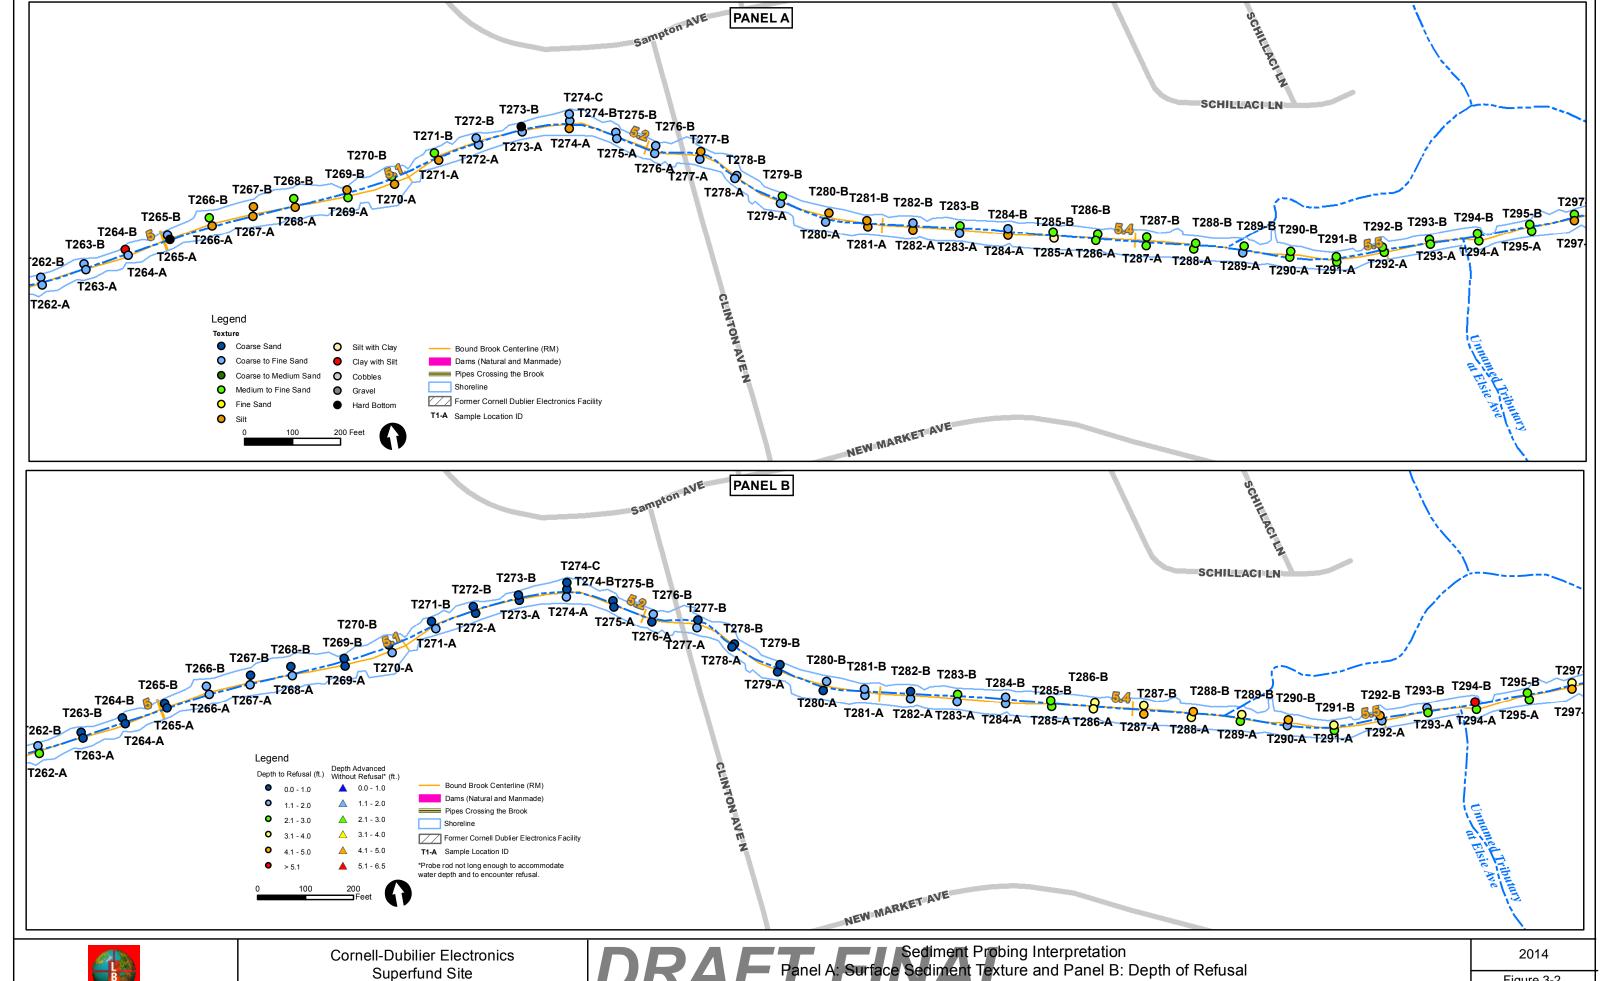
Figure 3-2 Sheet 9 of 11

Sediment Probing Interpretation
Panel A: Surface Sediment Texture and Panel B: Depth of Refusal
Bound Brook OU4 RI/FS

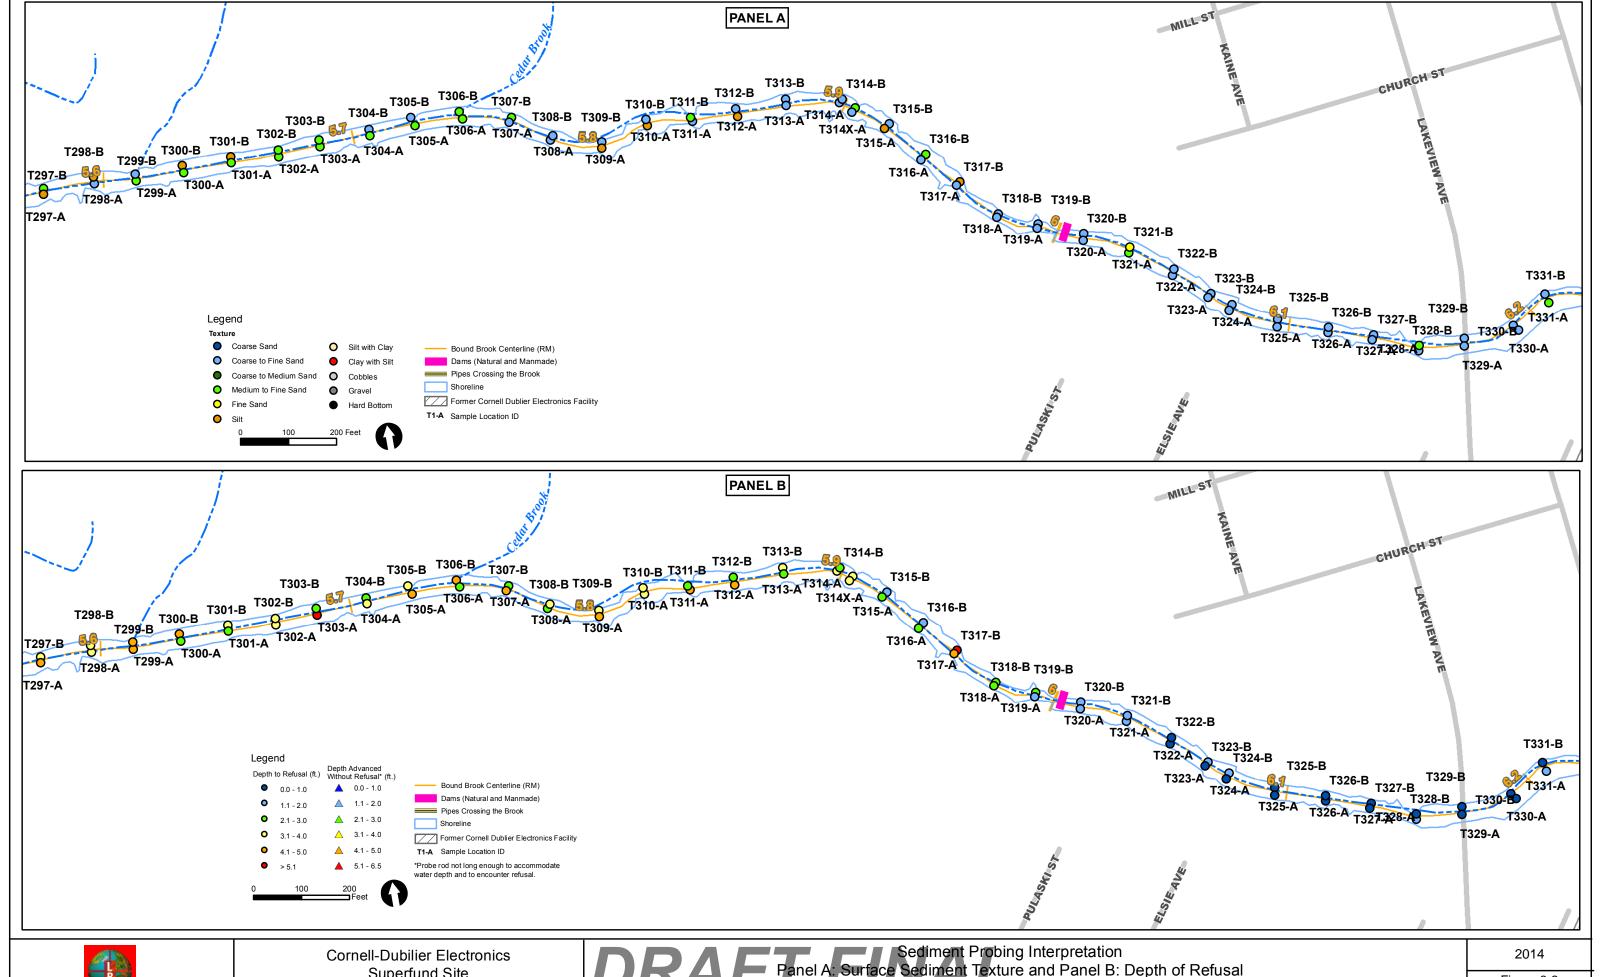
Figure 3-2 Sheet 10 of 11

Sediment Probing Interpretation
Panel A: Surface Sediment Texture and Panel B: Depth of Refusal
Bound Brook OU4 RI/FS

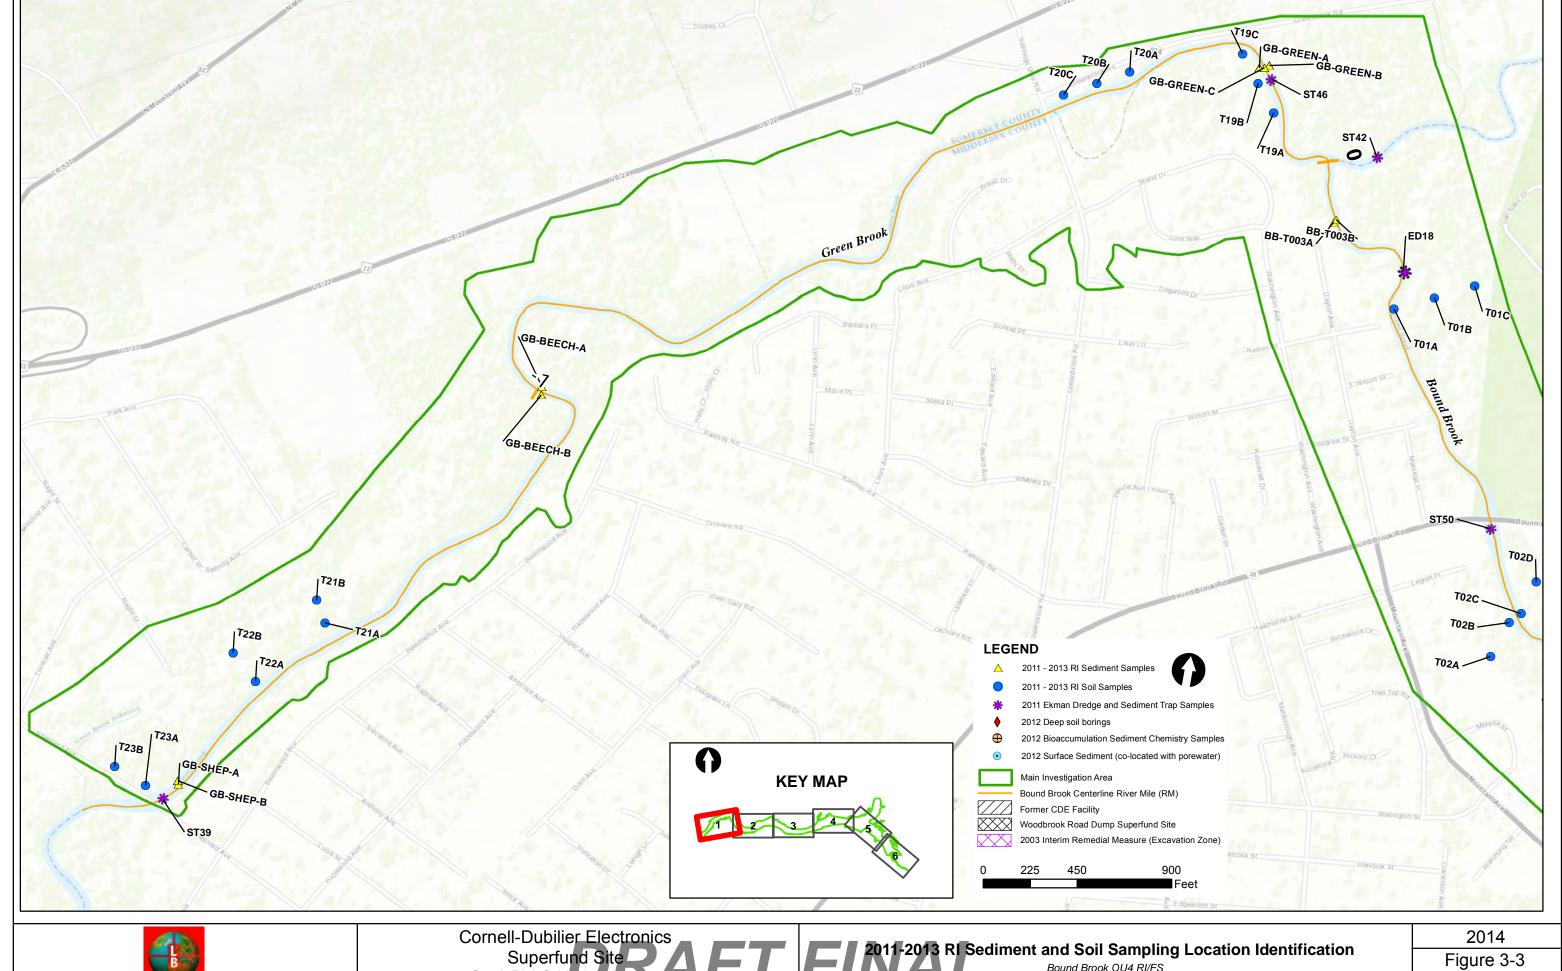
Sheet 1 of 6

2011-2013 RI Sediment and Soil Sampling Location Identification

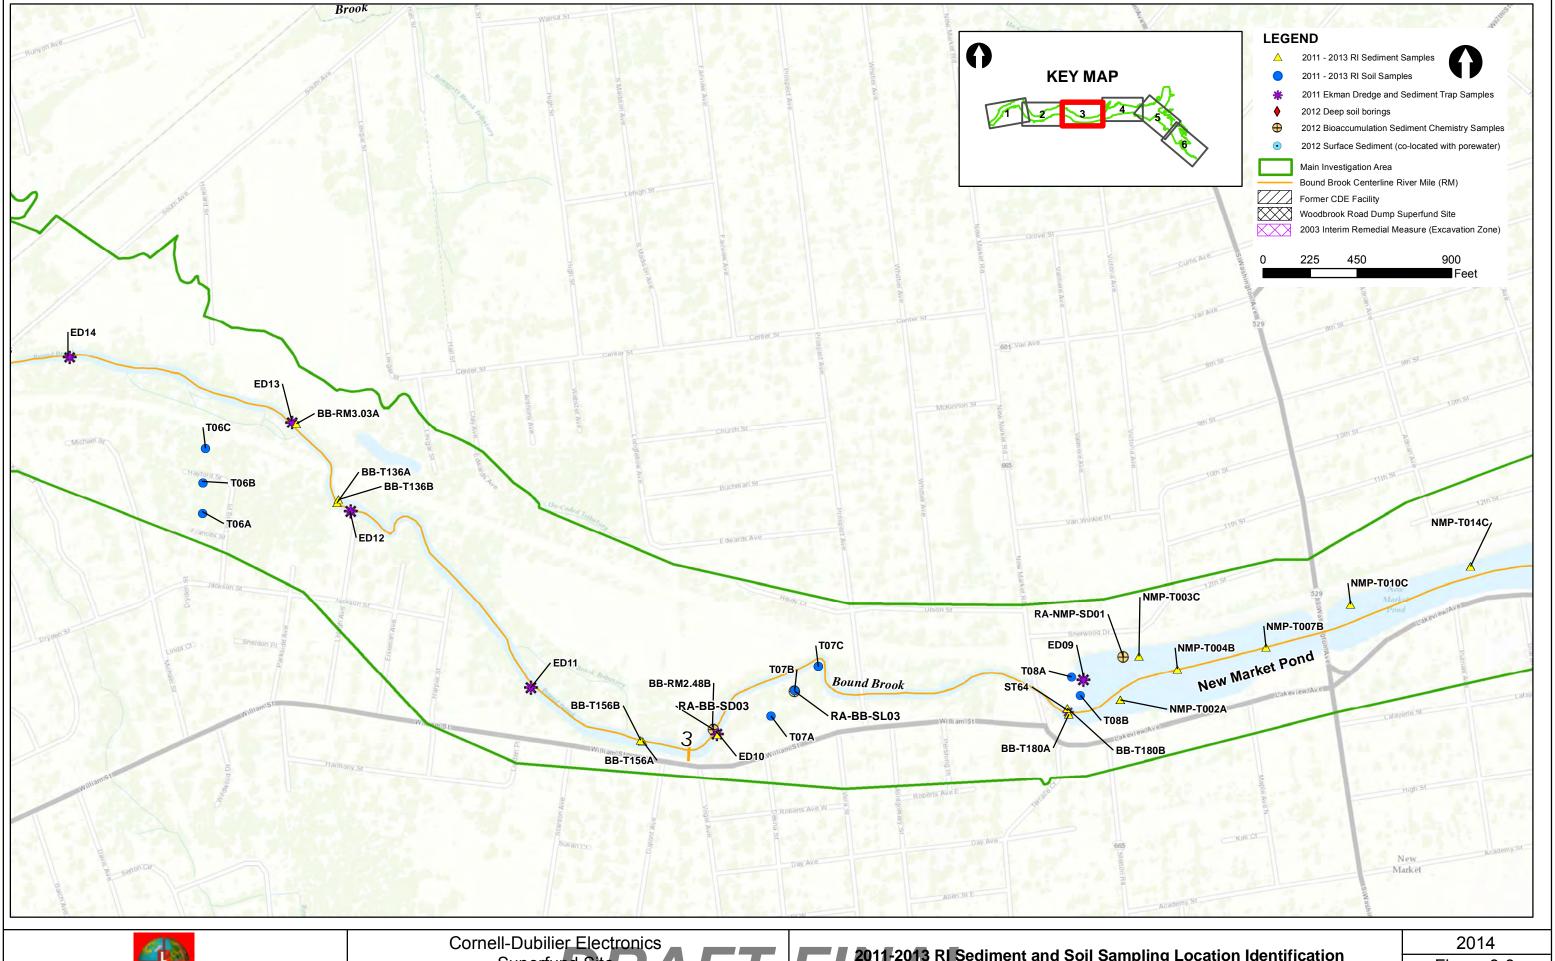
Figure 3-3 Sheet 3 of 6

2011-2013 RI Sediment and Soil Sampling Location Identification
